MINE FALLS DAM

NH 00116

PHASE I INSPECTION REPORT
NATIONAL DAM INSPECTION PROGRAM

MARCH 1979

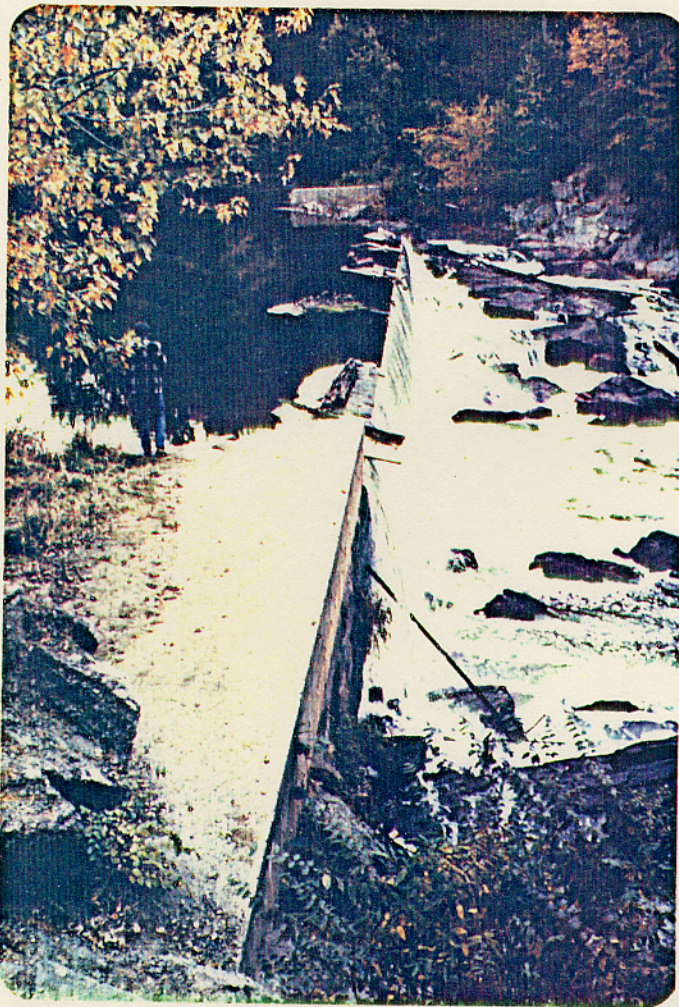
Overview of spillway from right end
of spillway

The spillway structure is in good condition without any evidence of displaced stones, bulges, or other signs of distress. The joints are almost void of mortar and seepage was observed at isolated locations.

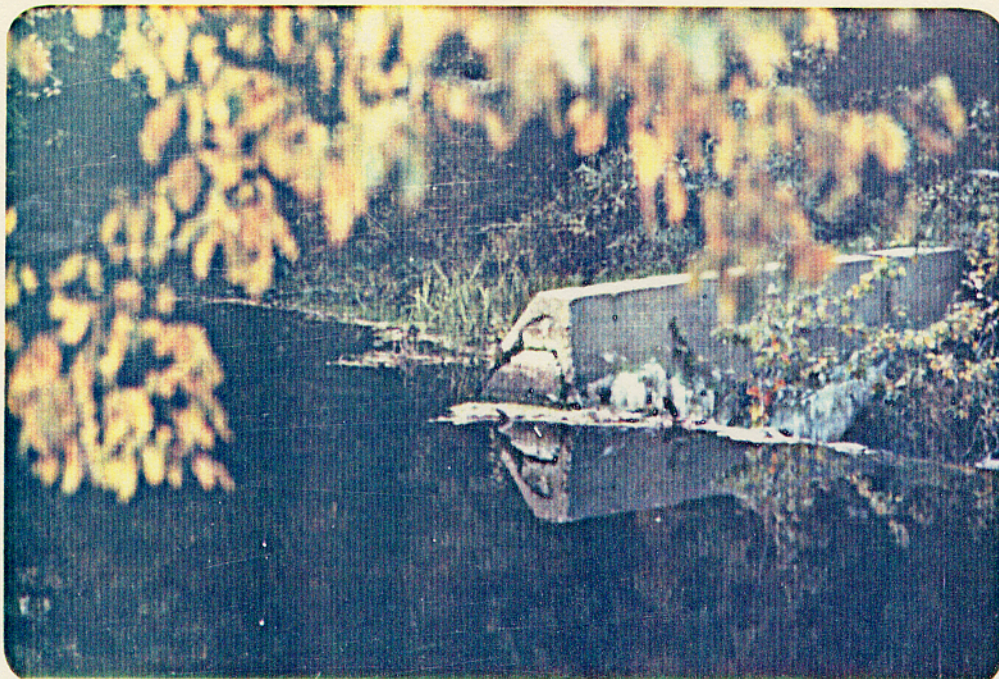
The upstream end of this structure adjacent to the spillway is badly eroded. This is attributed to ice damage and moisture intrusion which has been subjected to alternating freeze and thaw cycles. Visual observations of the upstream end revealed that the original concrete structure has been capped and faced on both sides with concrete. The capping raised the wall an additional two feet. A series of horizontal cracks with considerable efflorescence are located over the front face of the wall from the interface with the spillway for an approximate distance of 20 feet. The entire length of this wall is highly effloresced over approximately 80 percent of its surface area below the original top of the wall. The upstream face of the wall has a continuous horizontal crack at the former top elevation of the structure. This is up to 2 inches in width and is attributed to stress concentration created by the capping procedure.

1. View of left end wall showing concrete cap over old ogee section and deterioration of concrete

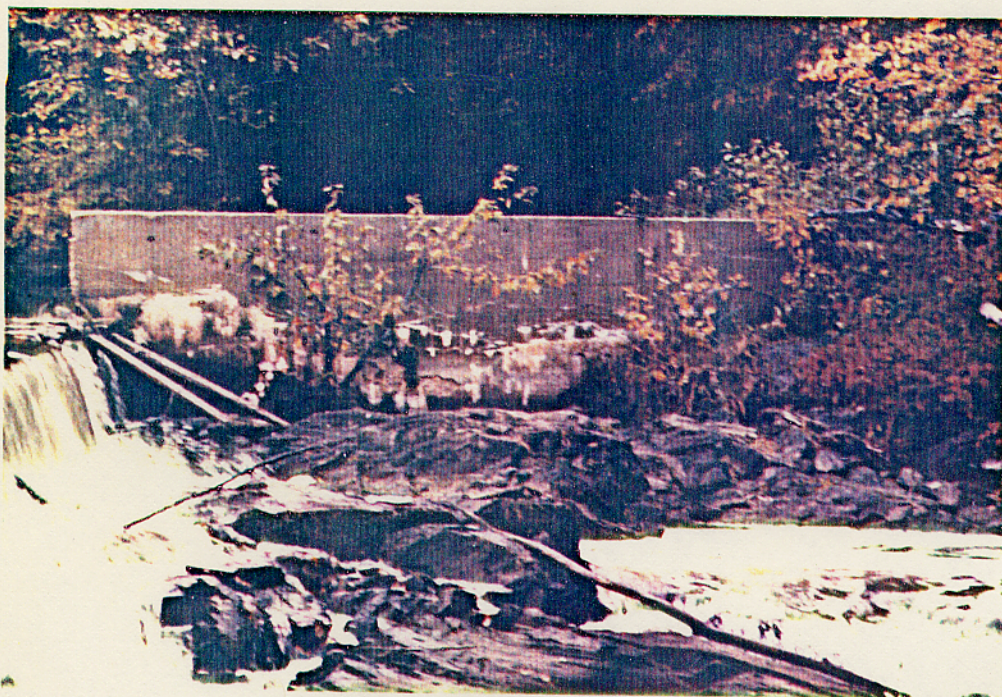
2. View of left endwall from downstream side

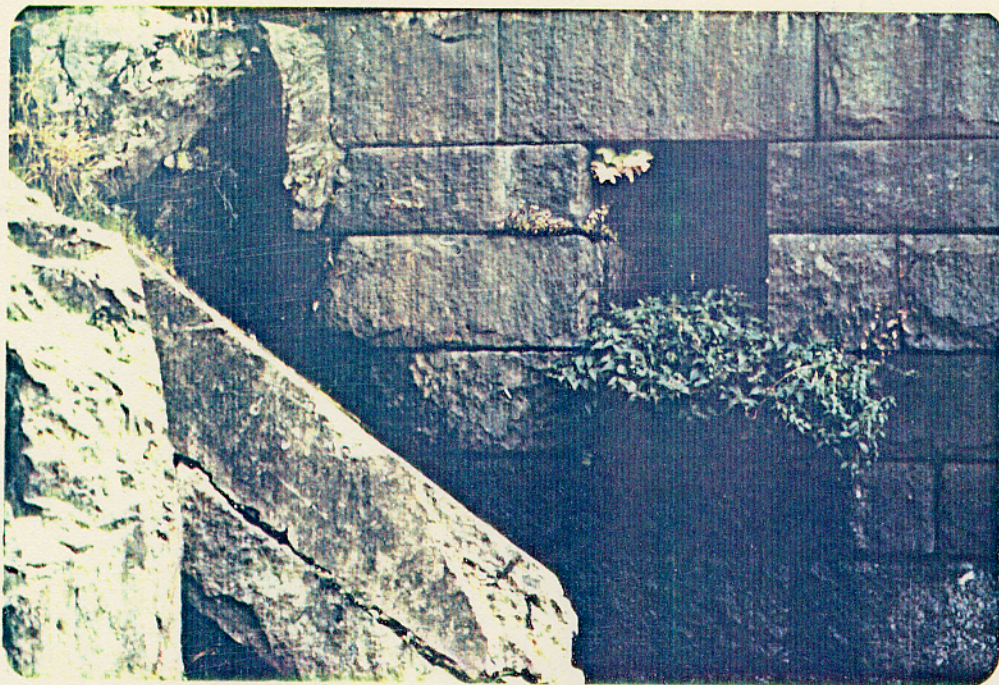
There is no evidence of cracks or spalls on this portion of the structure, however, there are isolated locations of minor efflorescence. A close observation of the stone masonry portion of this structure revealed that the quarried stone had been laid up in mortar but at the time of inspection the joint mortar was spalled. The stone masonry portion of this structure does not reveal any evidence of displaced stones, bulges, or other signs of distress. The masonry outlet of the upstream flume has been sealed with random cemented stone masonry. There is no evidence of seepage through the outlet. Vegetation is flourishing in the stone masonry at the flume outlet. It was observed that steady seepage, at extremely low flow rates, is flowing through the masonry joints in this structure. Steady seepage is also flowing through rock fissures adjacent to the right spillway end wall approximately 6 feet below its top surface, and the combined rate of flow is estimated to be approximately 10 to 15 gpm.

3. View from downstream of seepage at right spillway abutment and old flume

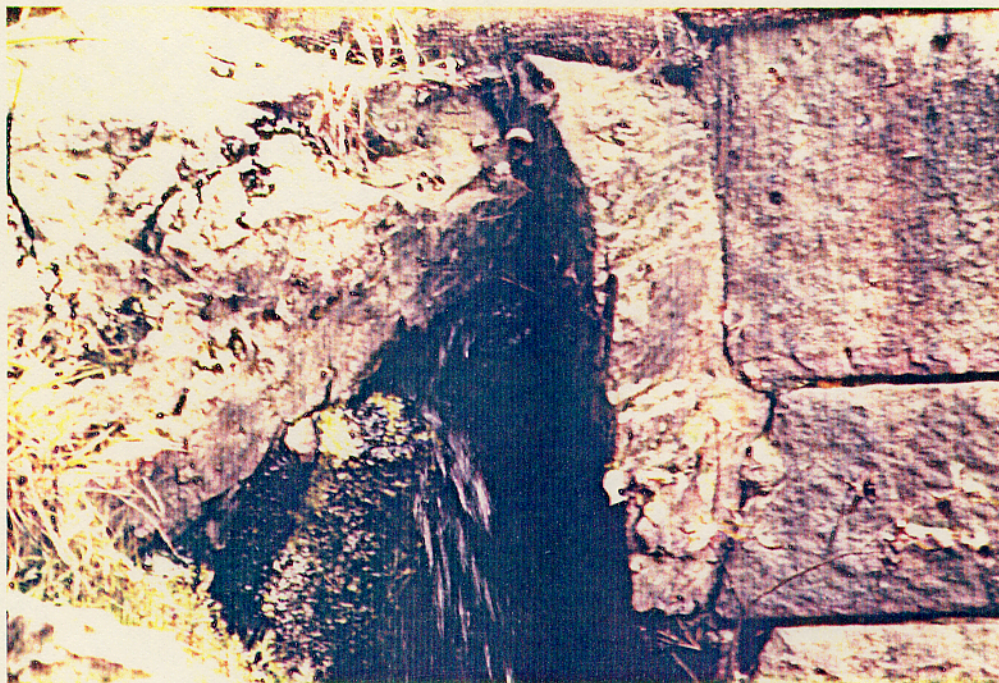
4. Detail view of seepage in photo 3 above

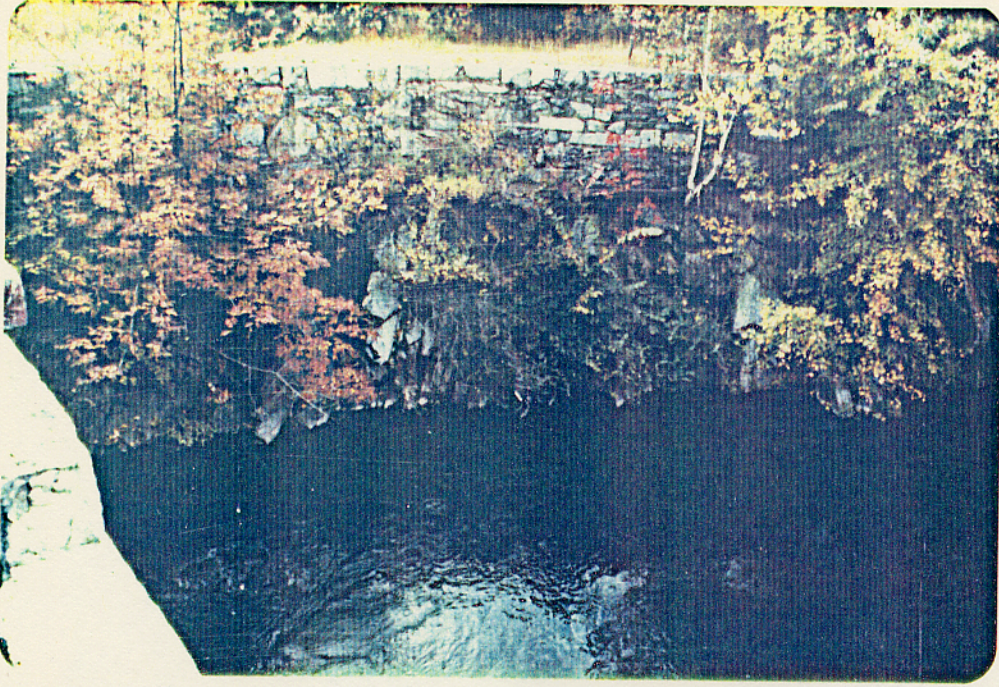
The canal training wall, which is made of cemented random stone masonry, is in fair condition. The return of this wall is in good condition. Visual observations revealed that the bedrock foundation of this structure has decomposed and eroded. In some instances this foundation erosion extends up to two feet under the stone masonry. Trees and saplings up to 6 inches in diameter are growing through the rock fissures at the wall base.

5. View of highly jointed rock under downstream canal training wall at left side of canal just downstream of headworks structure

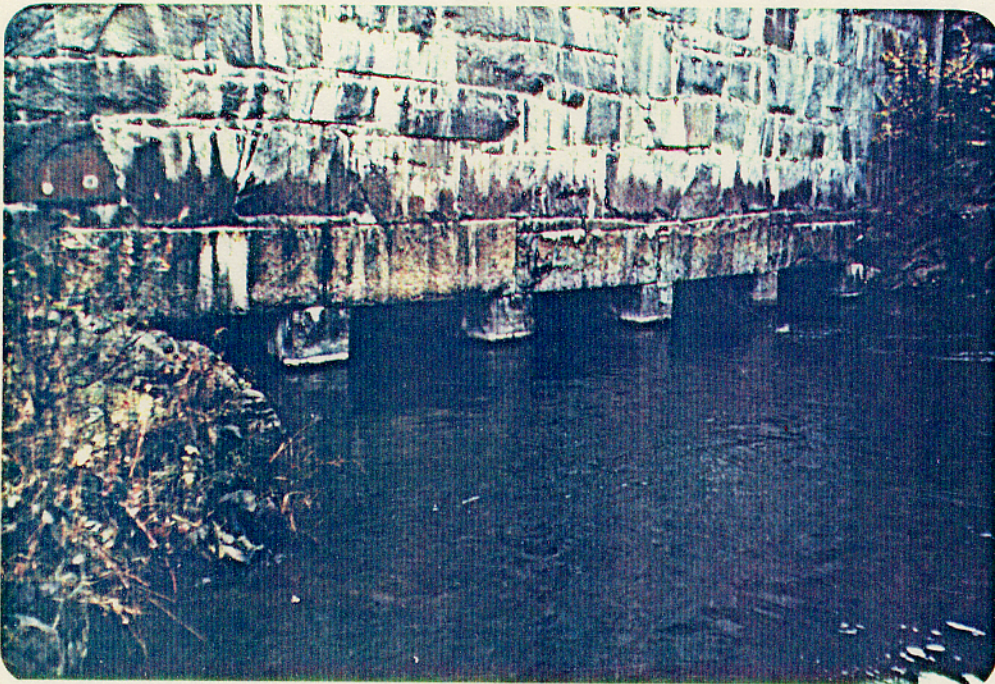
This structure also serves as the outlet for the five sluice gates. The outlet tunnels are made of cemented stone masonry and the exterior faces of these tunnels are supported on granite headers. With the exception of open joints over the intermediate pilasters, these headers are in good condition. Observations of the wall section between the end of the headworks structure and the right bank did not reveal any structural deficiencies. Remnants of a metal rail fence are evident over the length of this wall.

6. View of outlets for timber sluice gates of the headworks structure
